## DAMAGE DETECTION FROM HIGH-RESOLUTION SATELLITE IMAGES FOR THE 2003 BOUMERDES, ALGERIA EARTHQUAKE

### SUMMARY

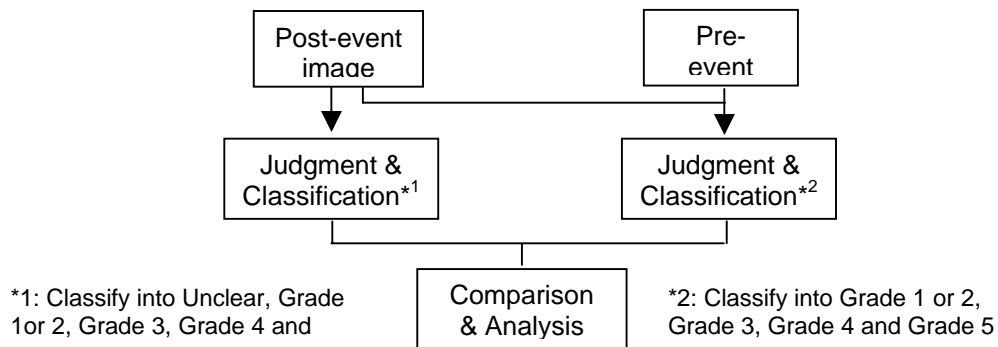
**Figure 4.** Flowchart to classify building damage

Visual inspection of building damage was conducted based on the classification in the European Macroseismic Scale [8], shown in **Table 2**. Using only the post-event (May 23, 2003) image and using both the pre- and post-event images, buildings surrounded by debris (Grade 3), partially collapsed buildings (Grade 4) and totally collapsed buildings (Grade 5) were identified. According to the flowchart shown in **Fig. 4**, the damage levels of buildings were classified.

Using the images of Zemmouri City, the visual inspection of building damage was also conducted based on the same classification as stated before (Fig. 4). For the purpose to obtain more confidence in the result of visual detection, five persons (actually the authors of this paper, who are researchers and graduate students in the fields of structural engineering) conducted visual inspection and the differences among their results were investigated.

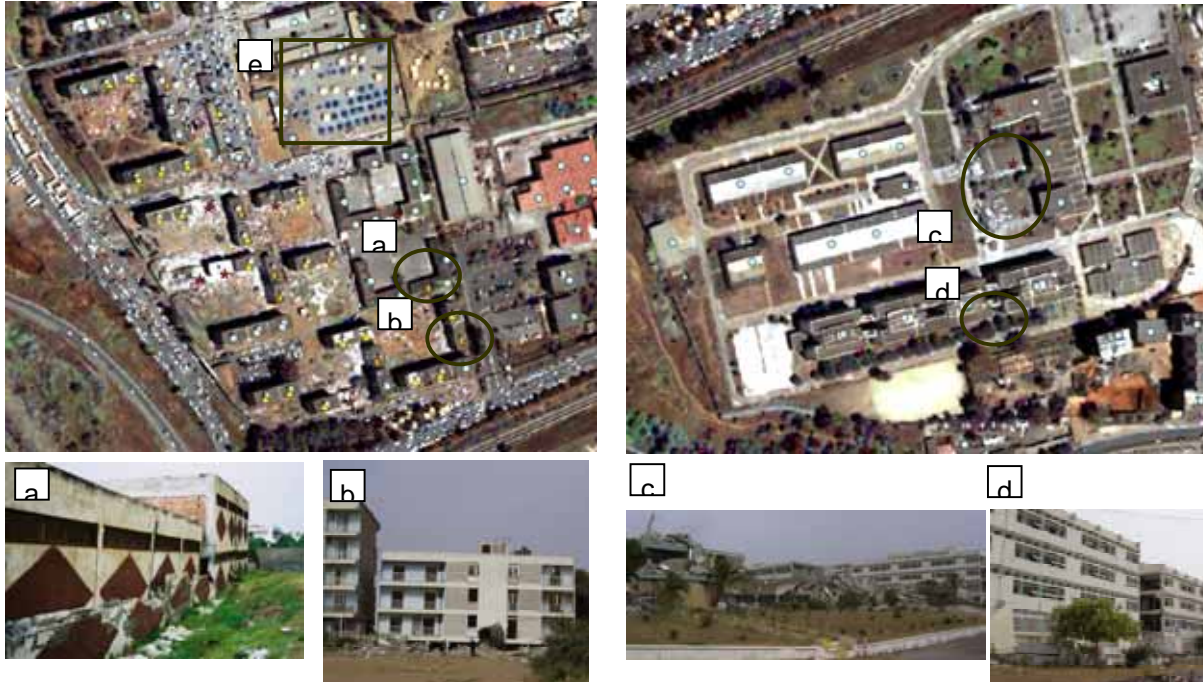
**Figure 5.** Comparison between the satellite images and on-site photographs (the on-site photographs are by courtesy of Prof. K. Meguro of The University of Tokyo).

**Figure 5** shows the comparison between satellite images and on-site photographs. In the satellite images, circle symbol means “Grade 1 or 2”, triangle “Grade 3”, diamond “Grade 4” and star “Grade 5”, respectively. The left satellite image in **Fig. 5** shows an example of heavily damaged areas. Buildings ‘a’ and ‘b’ were judged as Grade 4 based on visual interpretation. Compared with the ground photographs, it is observed that story collapses like these buildings are hardly judged with confidence from vertical images because the settlements are mostly to the vertical direction. Compared with ground photographs,

some buildings were judged incorrectly when little debris spreads or debris spreads in the shadow of buildings.

The right photographs in **Fig. 5** show the buildings in the south campus of Boumerdes University. Building 'c' is judged as Grade 5 and Building 'd' as Grade 1 or 2 based on visual interpretation. The ground photograph verifies the accuracy of the judgment for Building 'c' since their damages are apparent even from the vertical direction. Although Building 'd' was judged as no to moderate damage (Grade 1 or 2), the ground photograph indicates that it suffered from some damage (Grade 2 or Grade 3), especially inside the building. The field observation revealed that the debris seen in the photograph was gathered between the buildings in the stage of clearing works. These examples show difficulty to identify damages less than Grade 3. In the area of 'e', refugee tents can be seen.

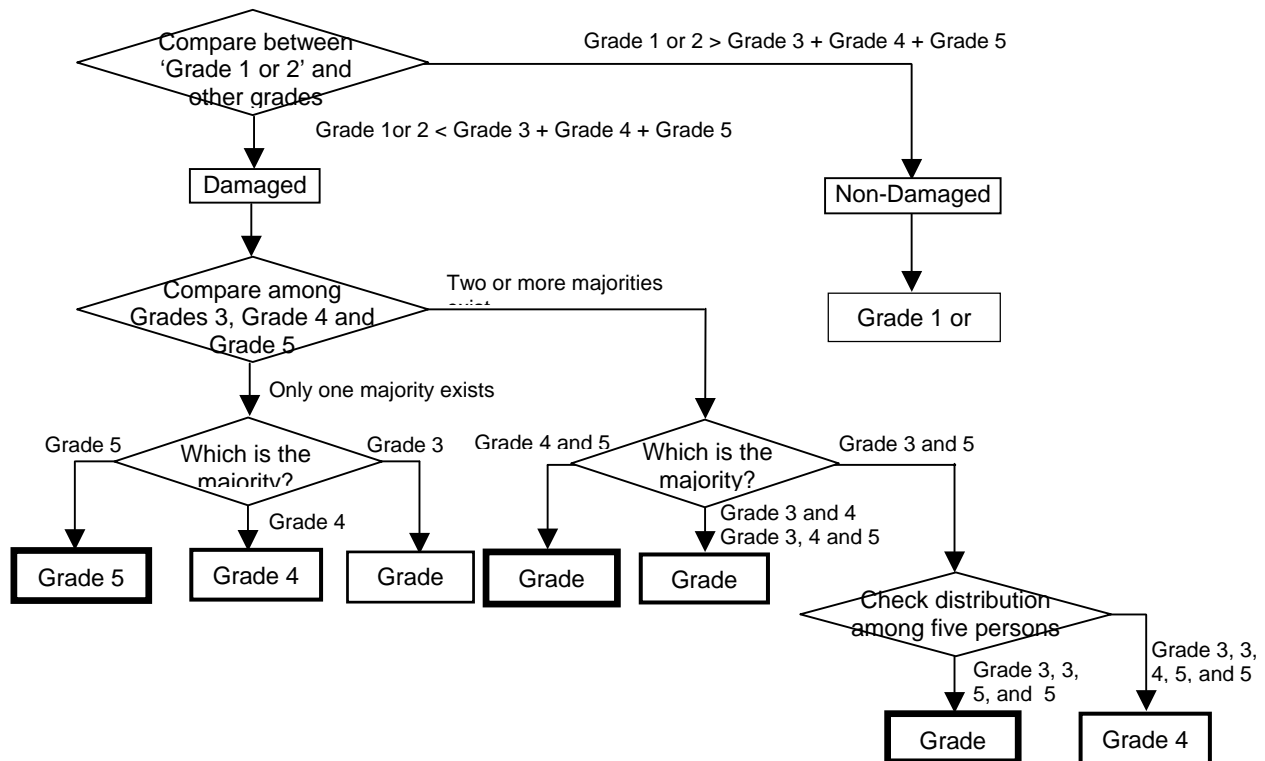
Figure 8. Flowchart to decide the majority damage level from the results by the five interpreters

Figure 8 shows the flowchart to determine “the majority damage level” from the individual detection results. First, comparing the number of persons who classified a building as “no damage” (Grade 1 or 2) with that as “damaged” (a total of Grades 3 to 5), if the former is majority, the damage level of the building is determined as “Grade 1 or 2”. If not, the damage level is determined in the next stage, by comparing between the numbers of persons who classified it as Grade 3, 4 or 5. Even after this procedure, the damage grade of some buildings cannot be determined. If the result by the five persons includes Grade 3 to 5, the damage level is classified as Grade 4. Otherwise the damage level is classified as the severer level.

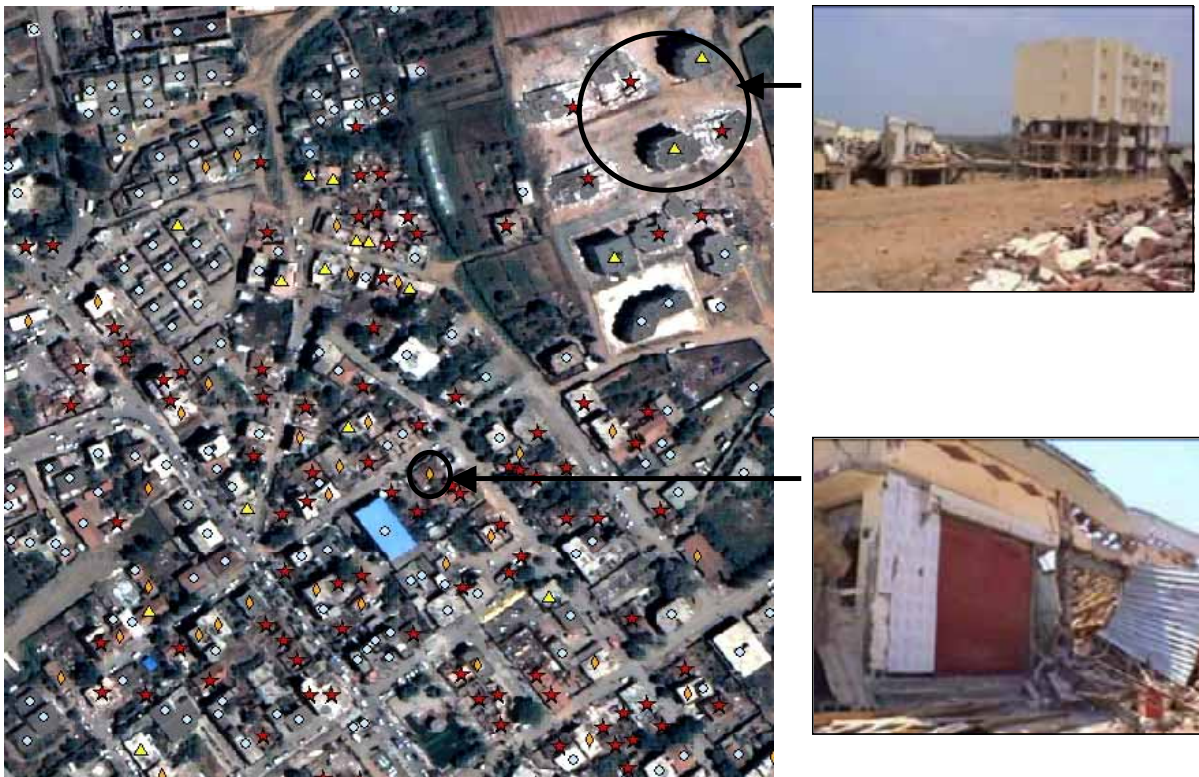
**Figure 10.** Comparison between the satellite images and on-site video pictures (the on-site video pictures are by courtesy of National Earthquake Engineering Center of Algeria).

**Figure 10** shows comparison between the satellite image and the on-site video pictures. In the satellite image, a circle symbol means “Grade 1 or 2”, a triangle symbol “Grade 3”, a diamond symbol “Grade 4”, and a star symbol “Grade 5”, respectively. The right-side pictures show a damaged low-rise house (the lower picture) and damaged/collapsed tall buildings (the upper one), which are examples that the detection results using satellite images were verified by ground photographs.
